## STEEL STRUCTURE FAILURE & LESSONS LEARNED

### Suspended Steel Walkway Collapse: Hanger Rod Connection Failure after a Detail Change

Hyatt Regency Hotel, Kansas City, Missouri, USA | 17 July 1981

| <b>CASE STUDY NO:</b> | IMBF-SF-002 |

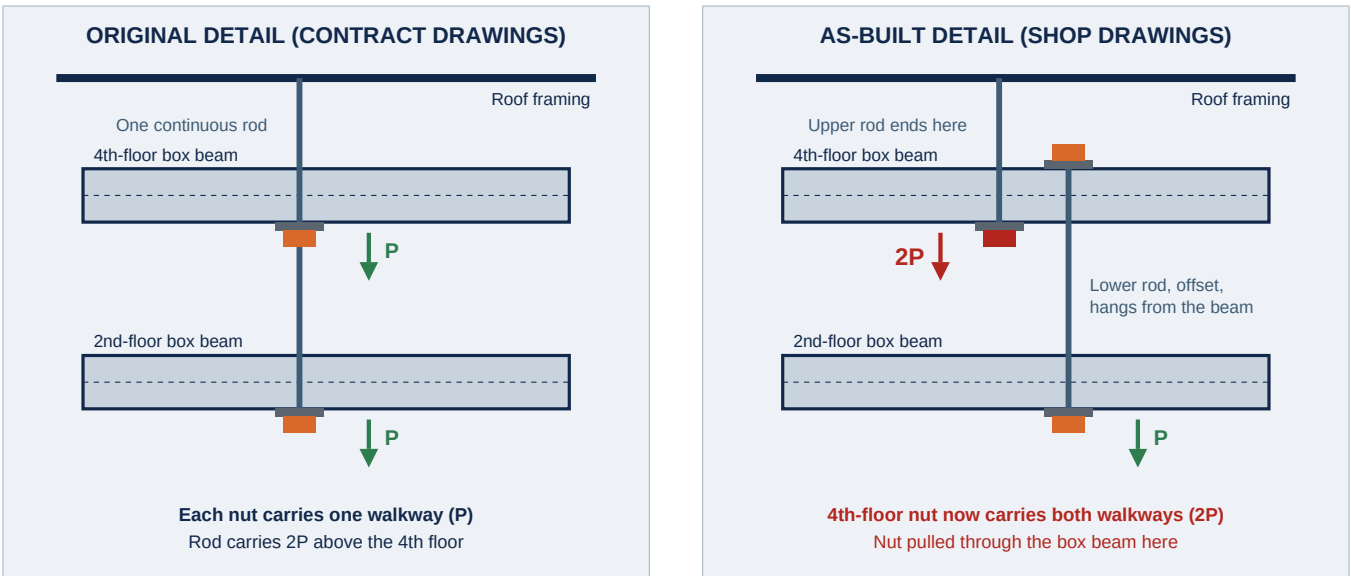
| Question | Answer |
|---|---|
| <b>Why?</b> | A change from one continuous rod to two offset rods about doubled the load on the fourth-floor connection, and the connection detail did not meet the building code even before the change. [S1] [S2] [S3] |

Figure 1. Original IMBF schematic of the hanger rod arrangement before and after the change. Conceptual, not to scale; one hanger line shown.  $P$  = load from one walkway at one hanger.

**Load doubling.** With one continuous rod, the nut under the fourth-floor beam carries only the fourth-floor walkway; the second-floor load stays in the rod. With two offset rods, the second-floor walkway hangs from the fourth-floor beam, so the nut under that beam carries both. The rod force above is the same in both cases; the connection force is not. [S1] [S2]

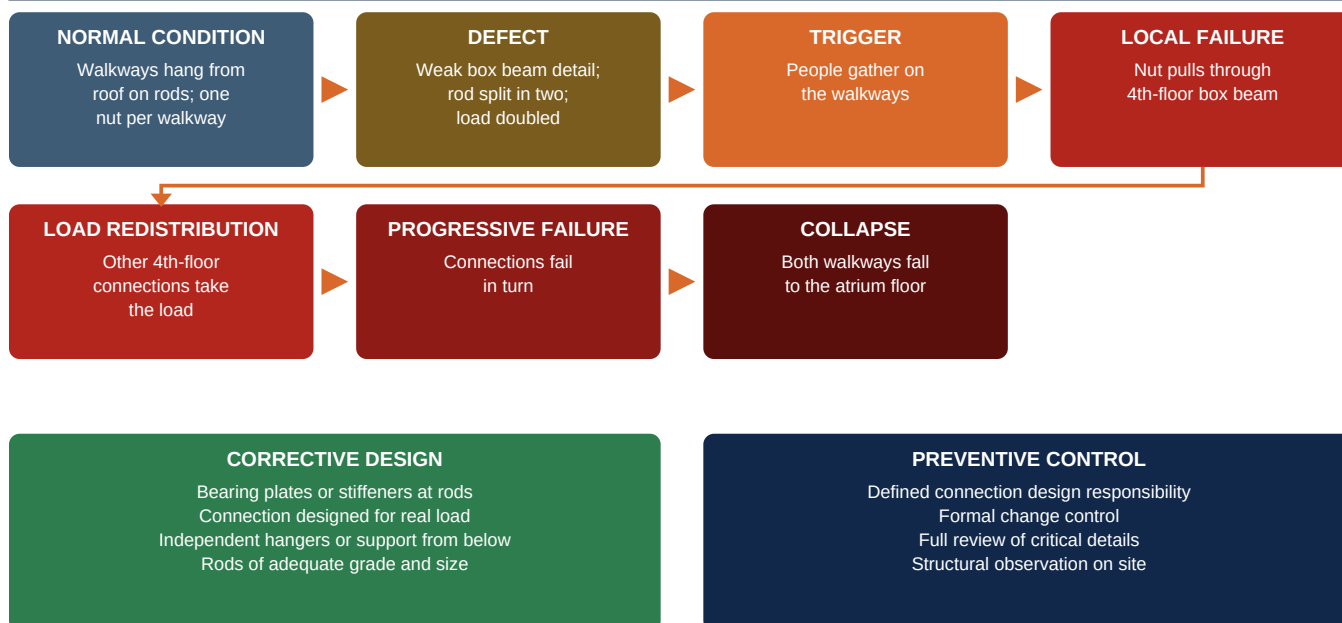
## 16 ORIGINAL IMBF FAILURE DIAGRAM

| Element | Identification |
|---|---|
| Failure mode | Local bearing and bending failure of the box beam flanges and rupture of the toe weld, letting the nut pull through; no redundancy to arrest it. [S2] |

**Weak detail.** The rod load was applied at the toes of the channel flanges, on the weld line, with no bearing stiffener or distribution plate. The flanges had to resist it by bending, away from the plane of the webs. [S2]

Original IMBF schematic. Conceptual, not to scale.

- Design every hanger connection for its real load, with bearing plates or stiffeners so that load enters the webs, not the flange toes.
- Prefer a load path in which loss of one connection does not drop the whole structure: support from below, or independent hangers for each level.
- Show connection design forces on the drawings whenever connection design is delegated.
- Treat any change of rod, bolt or support arrangement as a design change needing calculation and written approval.
