## STEEL STRUCTURE FAILURE & LESSONS LEARNED

### Steel Space-Frame Roof Collapse: Unbraced Compression Members under Snow Load

Hartford Civic Center Arena, Hartford, Connecticut, USA | January 1978

| CASE STUDY NO: | IMBF-SF-005 |

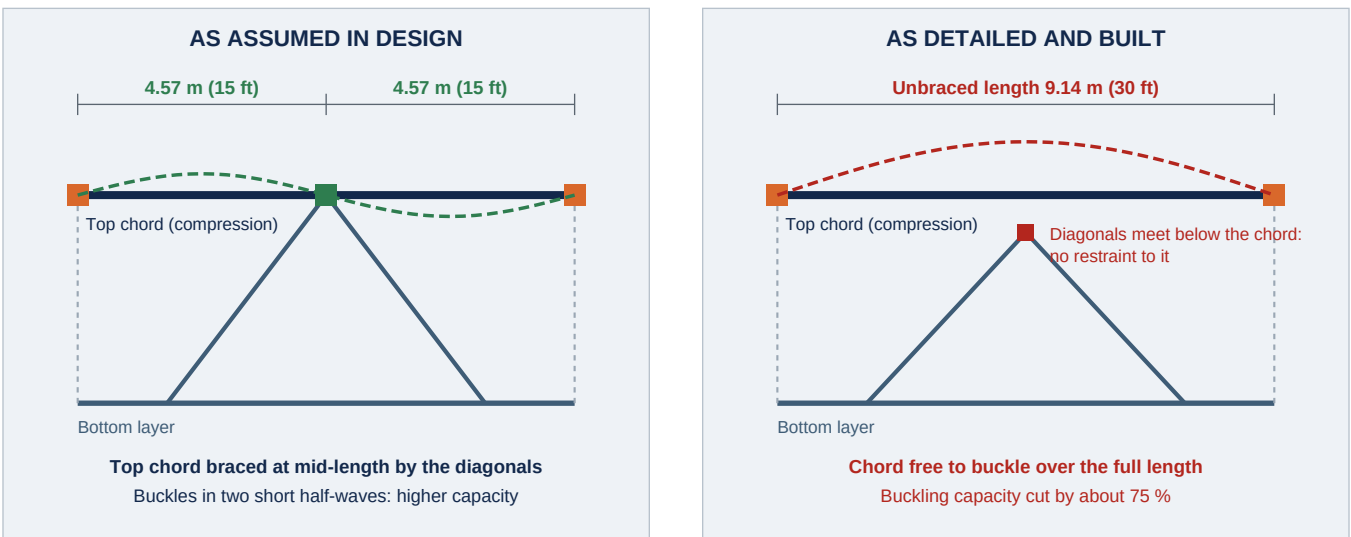
Figure 1. Original IMBF schematic of the top-chord bracing as assumed and as built. Conceptual, not to scale; buckled shapes exaggerated and shown in one plane for clarity.

**Buckling and unbraced length.** The load a slender compression member can carry falls with the square of its unbraced length. Doubling the length from 4.57 m to 9.14 m cuts the buckling capacity by about 75 %. The design assumed the shorter length; the built detail gave the longer one. [S1]

| Level | Statement |
|---|---|
| Contributing causes | Unbraced length twice the design value; weak cross-shaped section; eccentric nodes; 20 % extra dead load; material and fabrication deviations. [S1] |

- Use closed or I-shaped sections for compression members, with slenderness inside code limits.
- Make members meet at common nodes, and brace compression chords where the design says they are braced.
- Check member and system buckling explicitly, including torsional modes, and include real self-weight.
- Provide redundancy so that loss of a few members does not fold the frame.
- Compare measured deflection with prediction at each stage and resolve any large difference before proceeding.

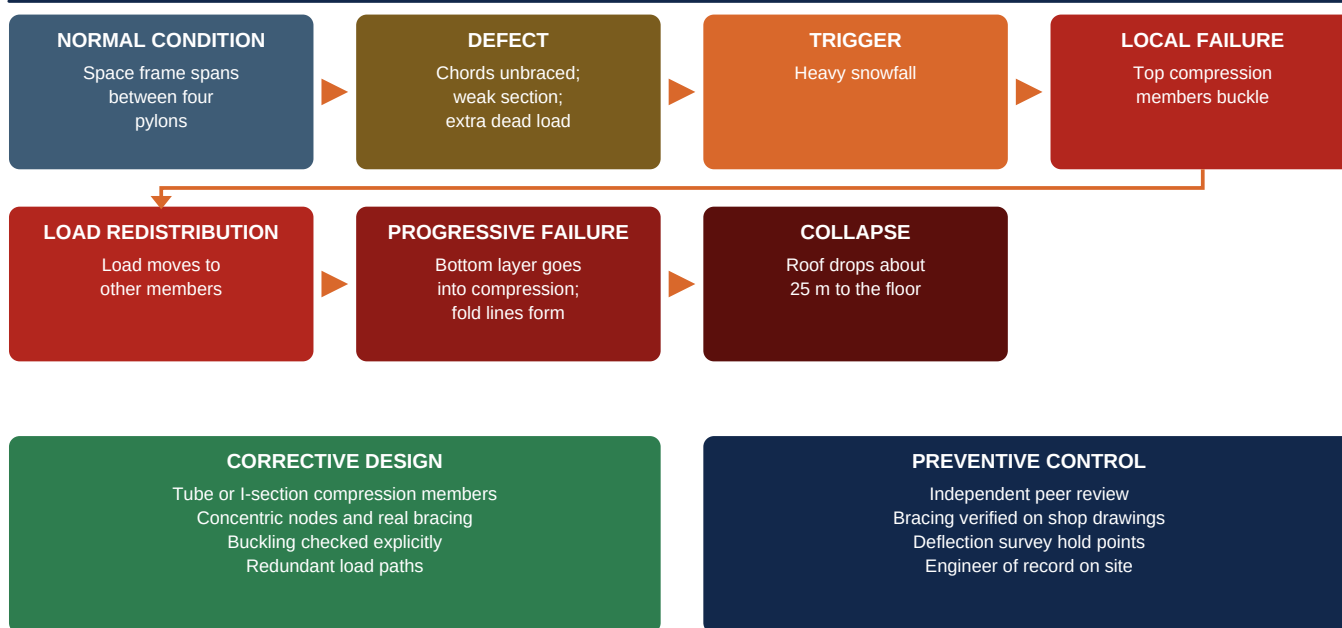
| Question | Answer |
|---|---|
| <b>What failed?</b> | Top-layer compression members buckled, the load moved to other members, and the whole frame folded. [S1] |

Original IMBF schematic. Conceptual, not to scale.
