## STEEL STRUCTURE FAILURE & LESSONS LEARNED

### Steel Space-Truss Roof Partial Collapses: Ice Ponds behind Parapets after Snowfall

Industrial plant with space-truss roof | Turkey (site not named in source)

| <b>CASE STUDY NO:</b> | IMBF-SF-006 |

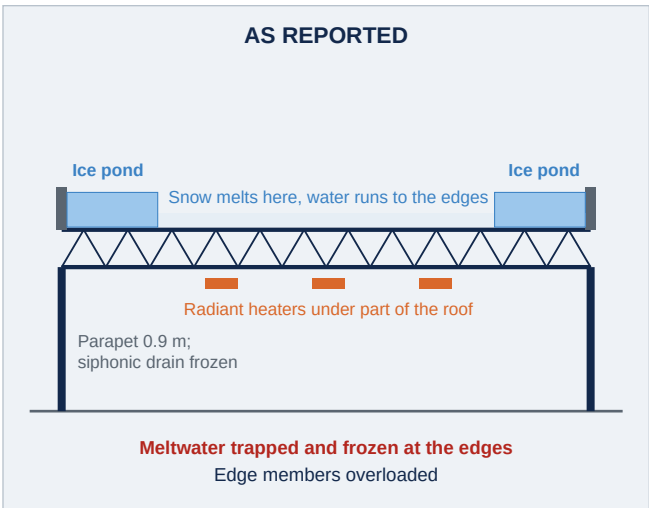
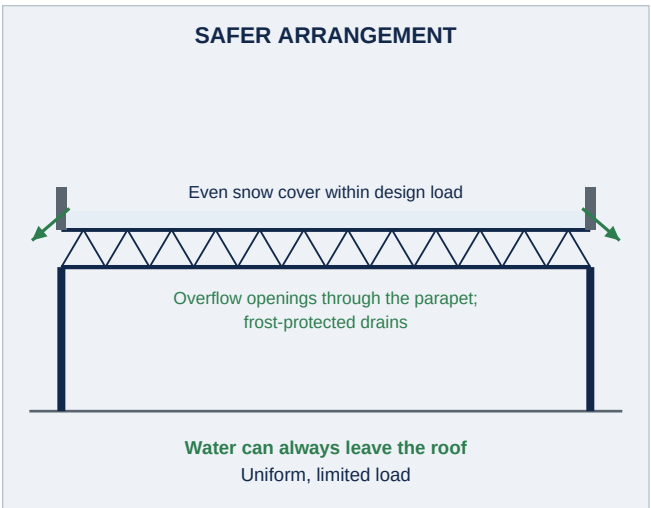
| Question | Answer |
|---|---|
| <b>Why?</b> | Ice ponds formed at the roof edges. Radiant heaters mounted on the roof structure heated only parts of the roof, so snow melted unevenly and the water ran to the edges, while the siphonic drainage froze. [S1] |

Figure 1. Reported cause: uneven heating melts snow, meltwater collects and freezes behind the parapets at the roof edges. Original IMBF schematic; conceptual, not to scale.

**Trapped water.** A 0.9 m parapet stops water leaving over the edge. With the siphonic drains frozen, the only outlet was blocked, so water depth could build far beyond a uniform snow load. [S1]

**Ice ponds.** The collected water froze. Ice is much denser than fresh snow, so a modest depth gives a high load, concentrated on the edge bays. [S1]

- Provide overflow openings or scuppers through parapets, set low enough to limit water depth to what the structure can carry.
- Protect drains from freezing where the climate requires, and keep a gravity overflow as back-up to siphonic systems.
- Check edge bays for drift and for retained water or ice up to the overflow level.
- Review heating layouts so that the roof is not partly melted from below, or insulate accordingly.

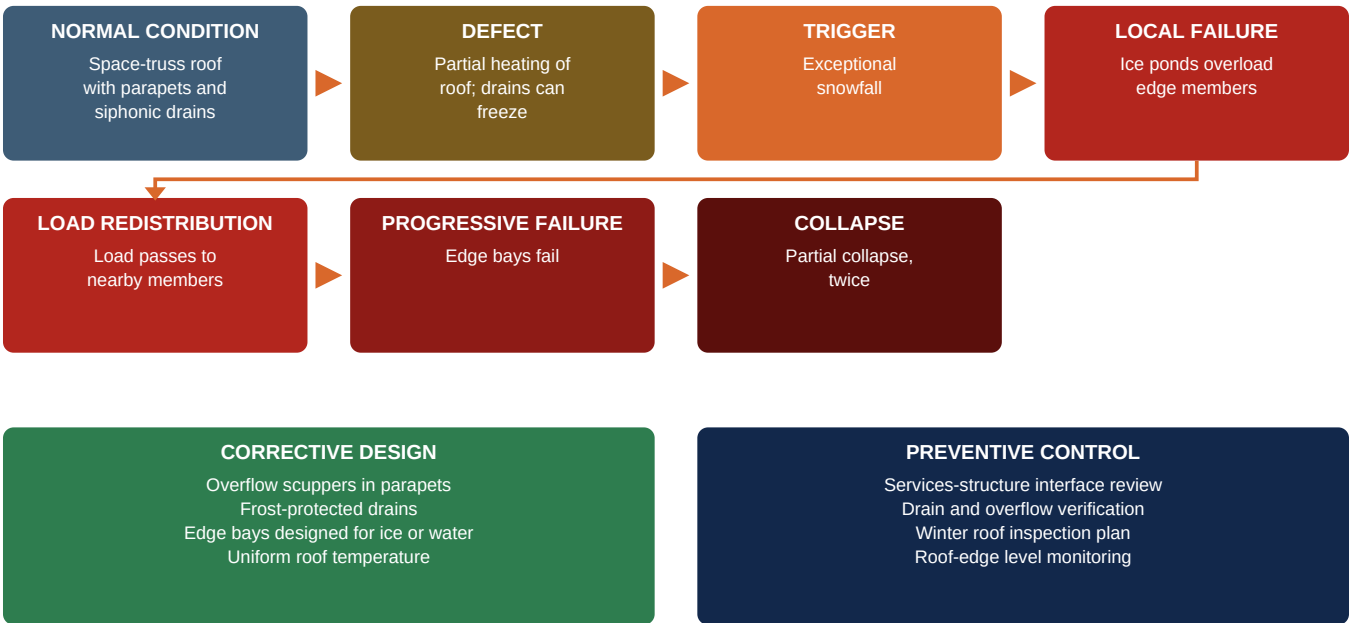
Original IMBF schematic. Conceptual, not to scale.
