## STEEL STRUCTURE FAILURE & LESSONS LEARNED

### Fabric-Covered Steel Frame Building Collapse: Bracing Assumed from Fabric, Wind below Design Speed

Dallas Cowboys Indoor Practice Facility, Irving, Texas, USA | 2 May 2009

| <b>CASE STUDY NO:</b> | IMBF-SF-007 |

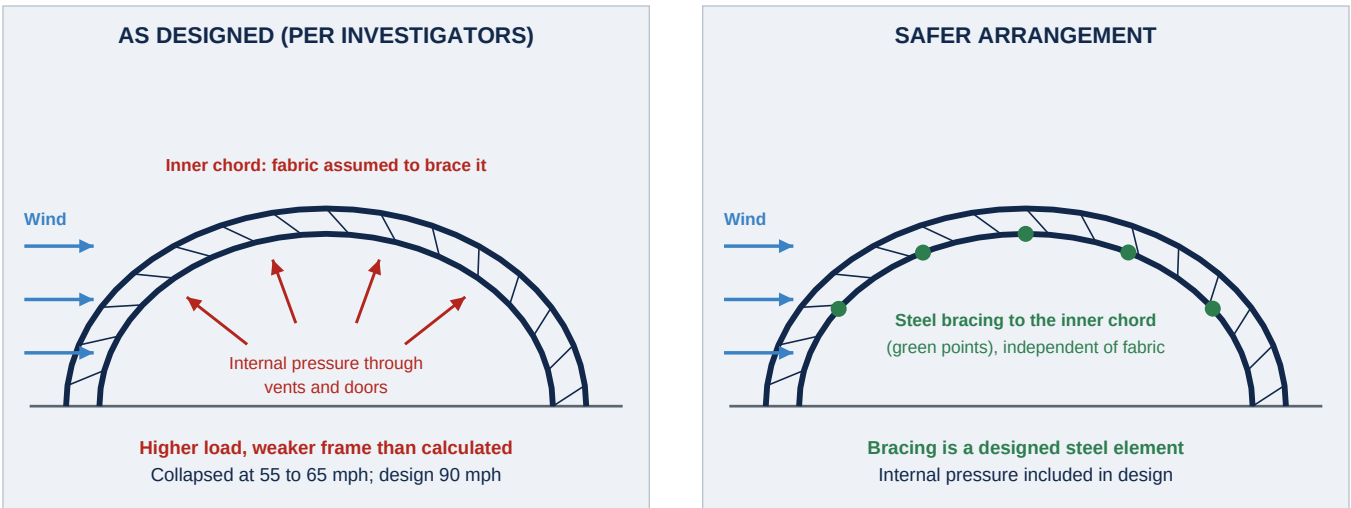
| Question | Answer |
|---|---|
| Why? | The structure failed under wind loads well below those required by the design standard. The investigators found three design assumptions that reduced safety: the building was treated as fully enclosed, the fabric was relied on to brace the frames laterally, and local bending in the frame members was not considered. [S2] |

Figure 1. Design assumptions questioned by the investigators, and the safer alternative. Original IMBF schematic; conceptual, not to scale.

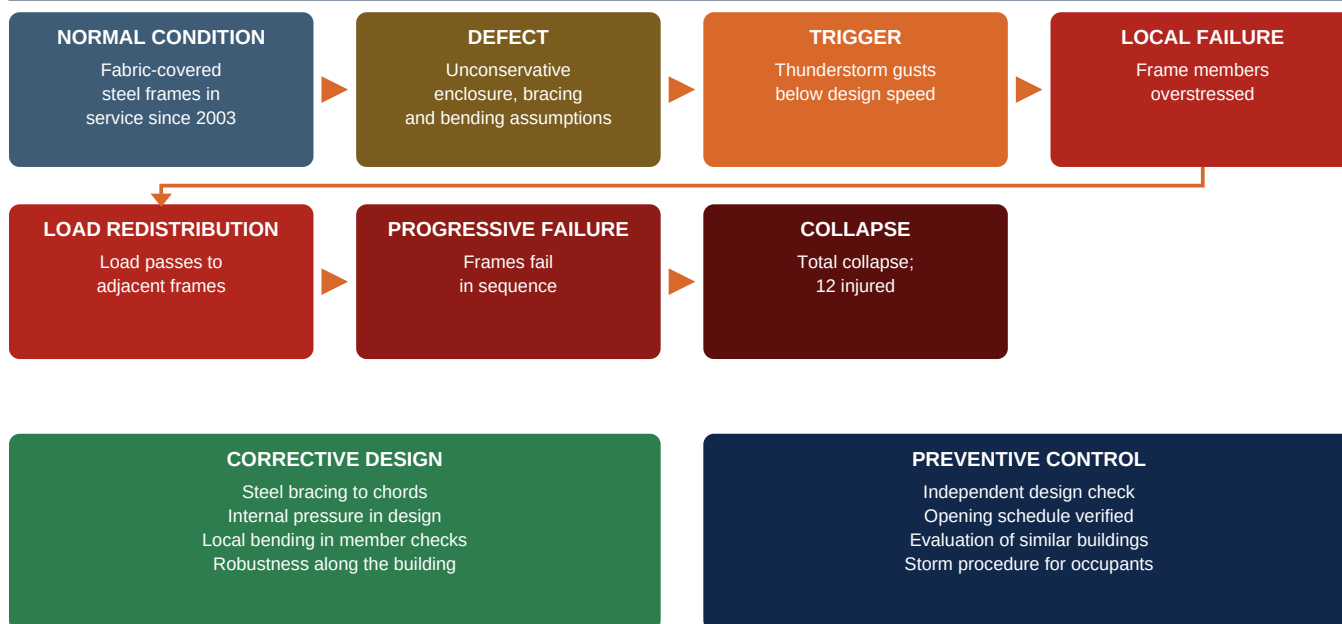
## 16 ORIGINAL IMBF FAILURE DIAGRAM

**Internal pressure.** Openings such as vents and doors let wind pressurise the inside of a building. Added to suction outside, this raises the net load on the frames. Treating the building as fully enclosed left this out. [S2]

**Bracing by fabric.** A compression chord needs lateral restraint at close spacing. The design counted on the fabric for this. Fabric can tear or go slack, and then the unbraced length, and the buckling load, change at once. [S2]

**Local bending.** Loads applied between panel points bend the chord locally, in addition to its axial force. The design documents did not show this was considered. [S2]

**Result.** With all three included, the investigators found that the structure could not carry even moderate wind, which matches collapse at 55 to 65 mph against a 90 mph design speed. [S2]

Original IMBF schematic. Conceptual, not to scale.

- Brace compression chords with steel members designed for the brace force; do not count on fabric or sheeting unless it is designed and detailed as a diaphragm.
- Classify enclosure from the real openings, and design for the resulting internal pressure.
- Include bending from loads between panel points in member checks.
- Check that failure of one frame does not bring down the row.
