## STEEL STRUCTURE FAILURE & LESSONS LEARNED

### Stadium Roof Collapse during Construction: Loads Applied before the Steel Structure was Stable

De Grolsch Veste stadium (FC Twente), Enschede, The Netherlands | 7 July 2011

| <b>CASE STUDY NO:</b> | IMBF-SF-008 |

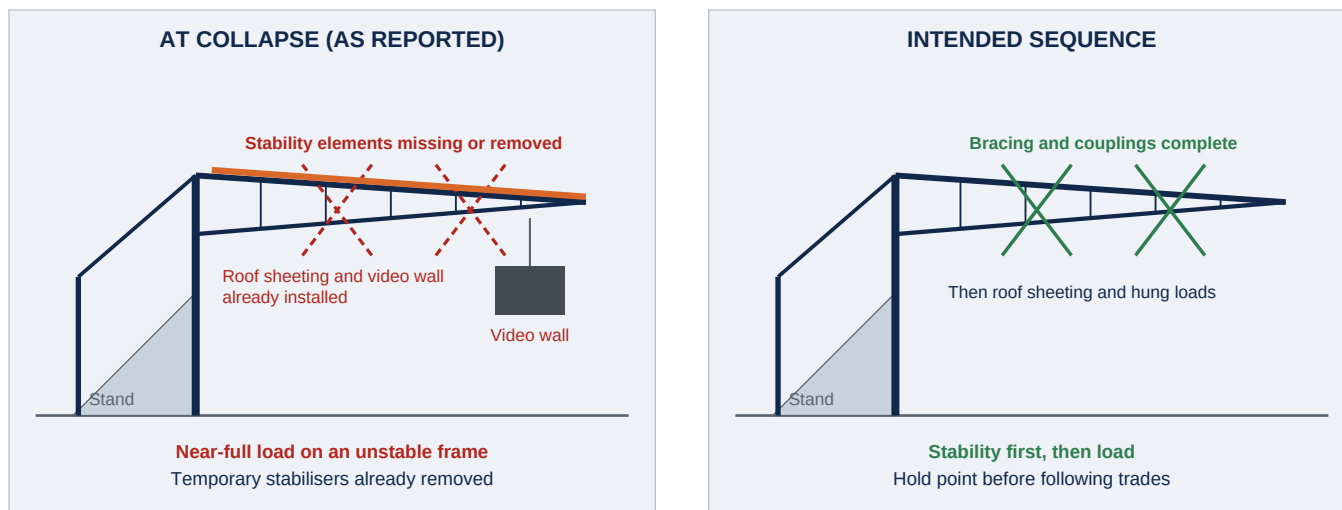
| Question | Answer |
|---|---|
| <b>Why?</b> | The roof was not yet stable on its own. Elements needed for stability were missing, temporary stabilising elements had been removed to ease other work, and nearly all the permanent loads were already on it. [S2] [S3] [S6] |

Figure 1. State of the roof at collapse as described in the consulted summaries, and the intended sequence. Original IMBF schematic; conceptual, not to scale.

**Loads ahead of stability.** Sheeting and a video wall were installed on the unfinished frame. The investigation concluded that a partly finished main structure carrying almost all final permanent loads caused the collapse. [S3]

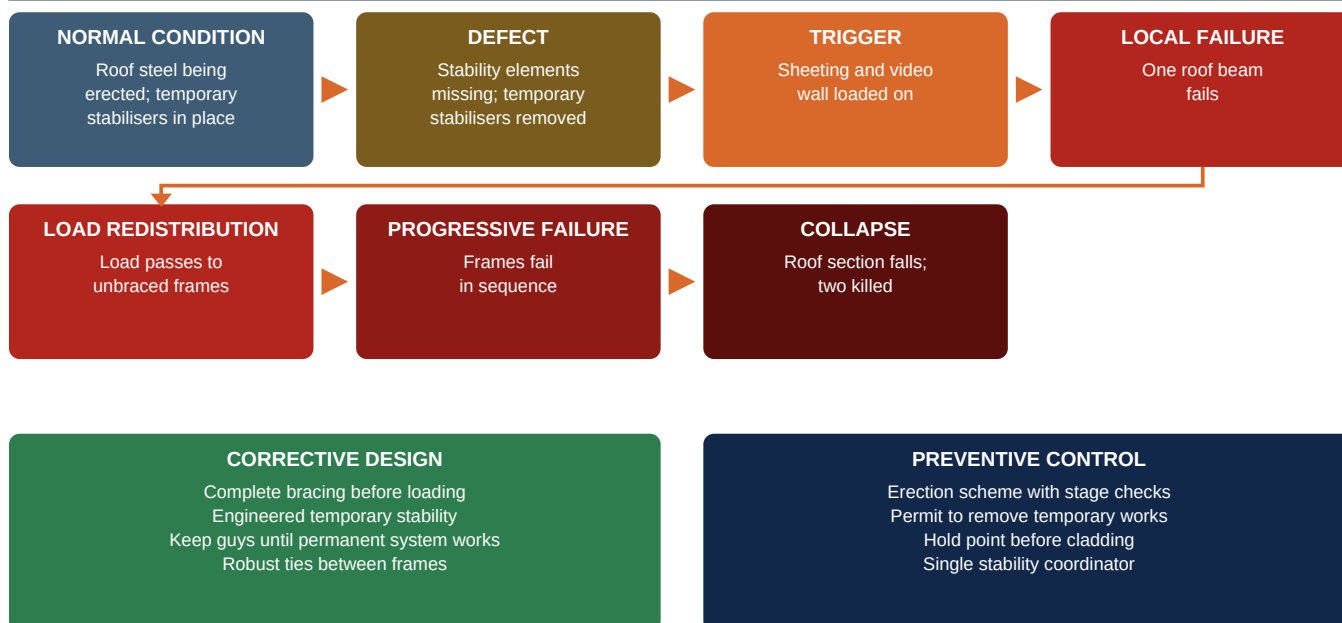
## 16 ORIGINAL IMBF FAILURE DIAGRAM

**Progressive collapse.** With frames tied together but not braced, failure of one member pulled down the rest of that part of the roof. [S4]

Original IMBF schematic. Conceptual, not to scale.
