## STEEL STRUCTURE FAILURE & LESSONS LEARNED

### Steel Column and Beam Collapse during Erection: Two-Bolt Base and Repaired Anchor Bolts Pulled Out

Steel erection site, Byhalia, Mississippi, USA | October 1992

| <b>CASE STUDY NO:</b> | IMBF-SF-009 |

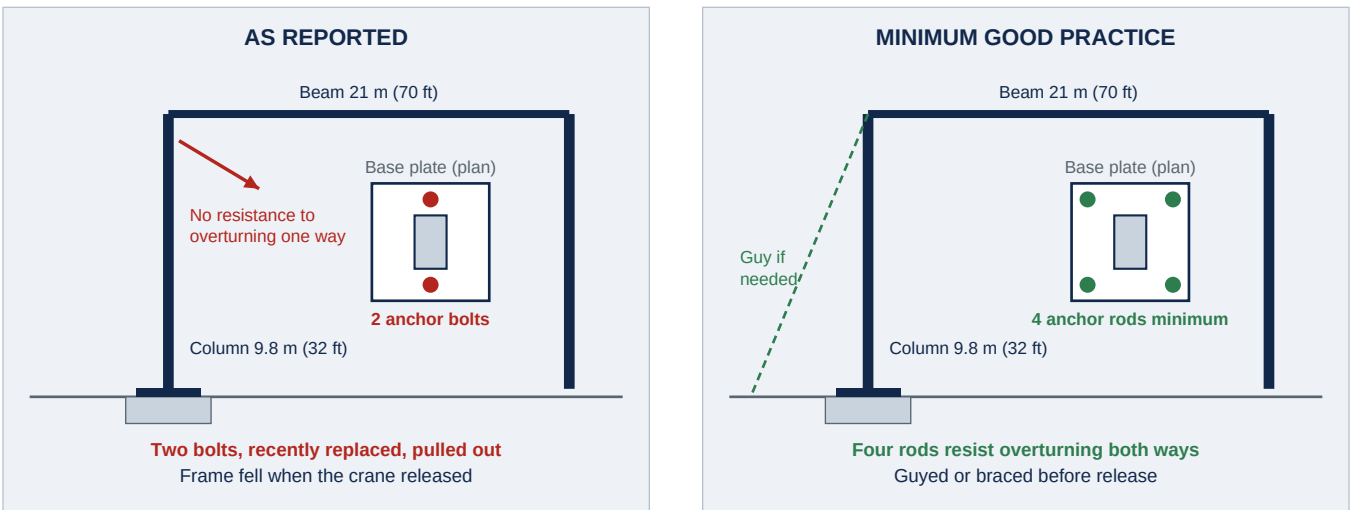
| Question | Answer |
|---|---|
| <b>What failed?</b> | The anchorage of one column: two anchor bolts pulled out of the concrete footing. [S1] |
| <b>Why?</b> | The columns had only two anchor bolts each, and the two that pulled out had been damaged and replaced several days earlier. [S1] |

Figure 1. Column base as reported and the present-day minimum for erection stability. Original IMBF schematic; conceptual, not to scale.

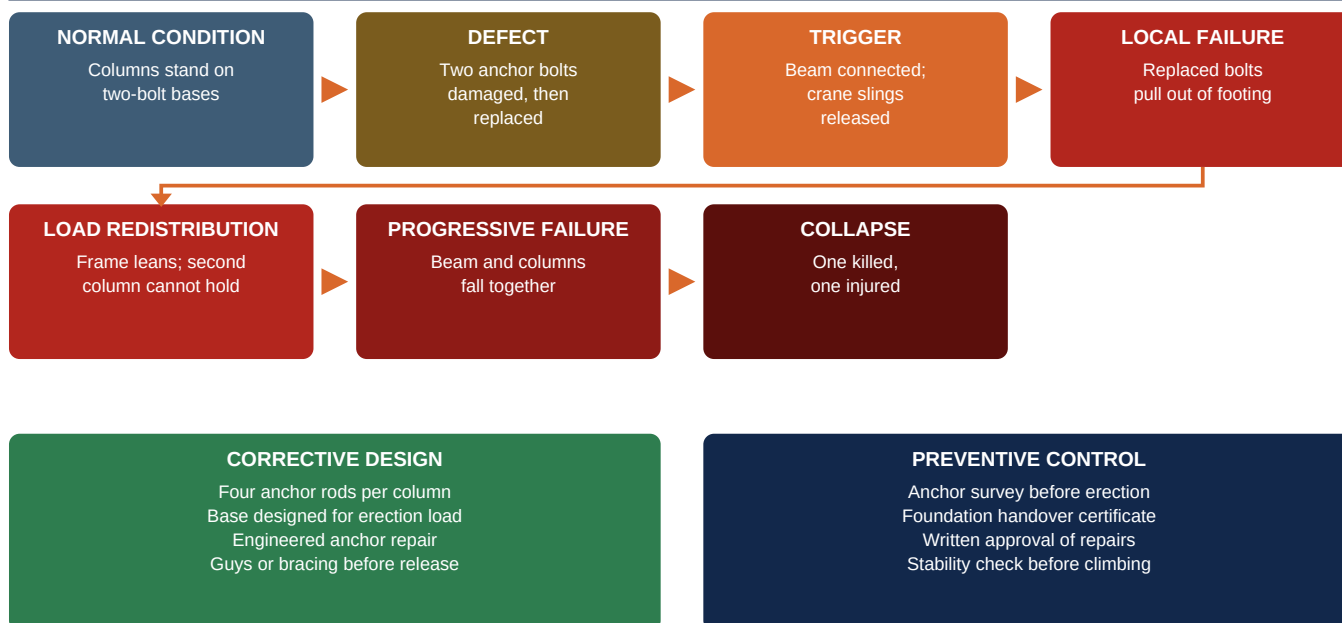
## 16 ORIGINAL IMBF FAILURE DIAGRAM

**Repaired anchors.** A bolt re-set in drilled holes or in fresh grout has the strength of that repair, not of the original cast-in bolt. If the repair has not cured, or was not designed, it can pull out at a small load. Here the two bolts that pulled out were the replaced ones. [S1]

**No second line.** No guys or bracing are reported. When the base let go, nothing else held the frame. [S1]

Original IMBF schematic. Conceptual, not to scale.

- Provide at least four anchor rods per column, arranged to resist overturning in both directions.
- Design the base, rods and footing for a defined erection load at the top of the column.
- Any damaged, bent, cut or misplaced anchor rod is repaired only to an engineer's written detail, with curing time and, where needed, a proof test.
- Guy or brace columns until the permanent bracing is connected; keep the crane hooked until then.
