## STEEL STRUCTURE FAILURE & LESSONS LEARNED

### Metal Building Warehouse Distress: Stored-Product Pressure and Column Bases Built Fixed but Modelled as Hinged

Two cottonseed storage warehouses (manufactured metal buildings) | Location not named in source

| <b>CASE STUDY NO:</b> | IMBF-SF-010 |

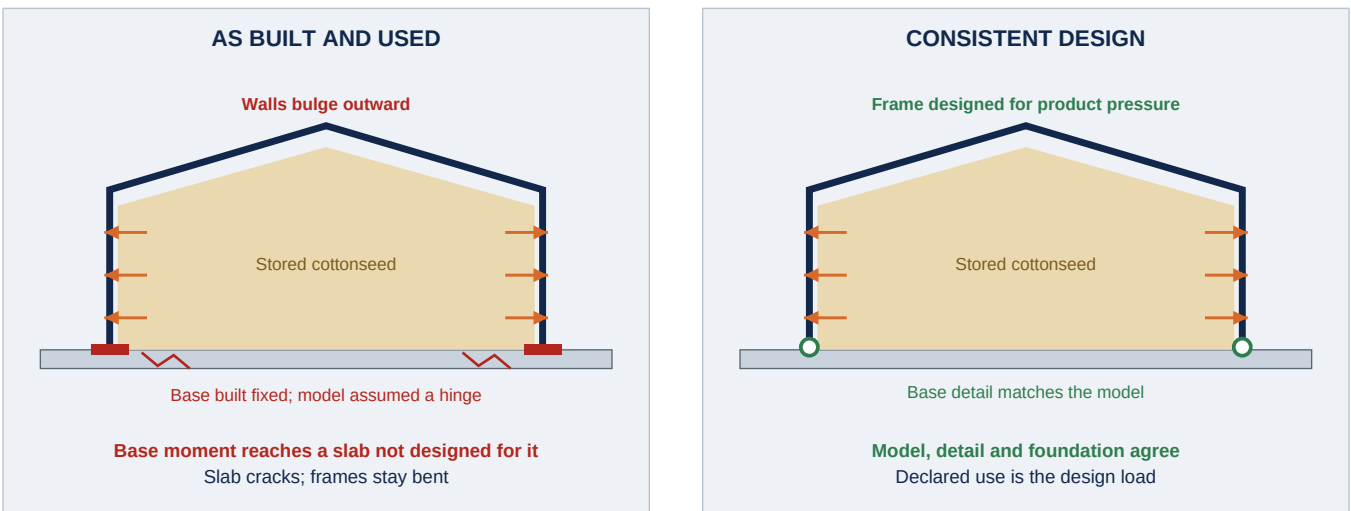
| Question | Answer |
|---|---|
| Why? | The stored product pushed outward on the walls. The column bases were built as fixed connections, but the structural model treated them as hinged, so the moment at the base was designed for by neither the building engineer nor the foundation engineer. [S1] |

Figure 1. Mismatch between the analysis model and the built column base under stored-product pressure. Original IMBF schematic; conceptual, not to scale.

**Model and detail mismatch.** A hinged base sends no moment to the foundation; a fixed base does. The frame was analysed one way and built the other. The real base moment went into a slab that was never designed for it. [S1]

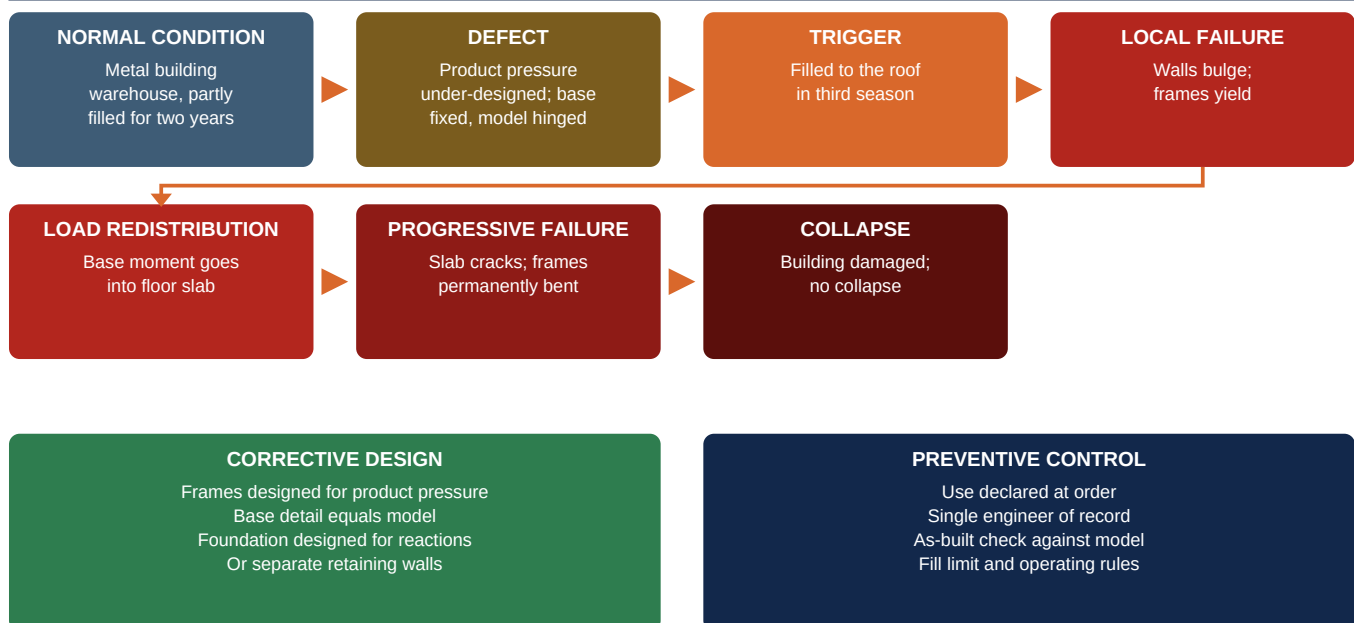
## 16 ORIGINAL IMBF FAILURE DIAGRAM

Original IMBF schematic. Conceptual, not to scale.
