## STEEL STRUCTURE FAILURE & LESSONS LEARNED

### Suspended Steel Roof Collapse: Rainwater Ponding and Hanger Bolt Failure

Kemper Arena, Kansas City, Missouri, USA | 4 June 1979

| <b>CASE STUDY NO:</b> | IMBF-SF-001 |

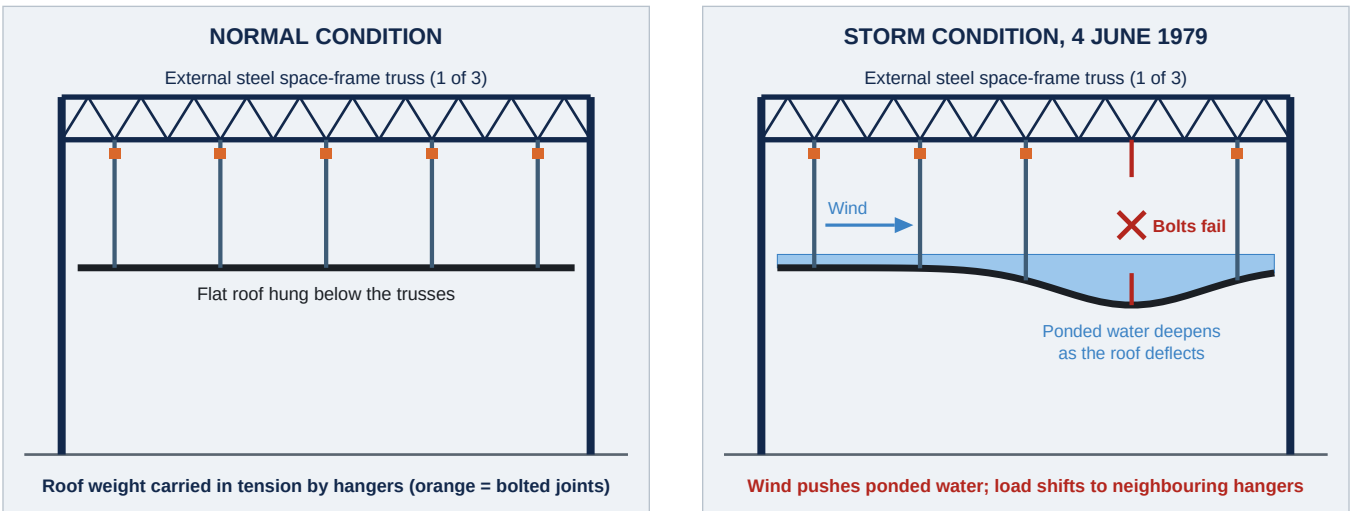
| Question | Answer |
|---|---|
| <b>Why?</b> | Rainwater ponded on a roof designed to hold storm water, wind added load and pushed the water toward one area, and the hanger bolts had been weakened by about five years of fluctuating load. The hanger system had no redundancy. [S1] |

Figure 1. Original IMBF schematic of the load path and the reported failure sequence. Conceptual, not to scale; member arrangement simplified.

| Element | Identification |
|---|---|
| Failure mode | Fracture of bolts under fluctuating tension (fatigue-weakened), triggered by ponding plus wind; then progressive (disproportionate) collapse for lack of an alternative load path. [S1] |

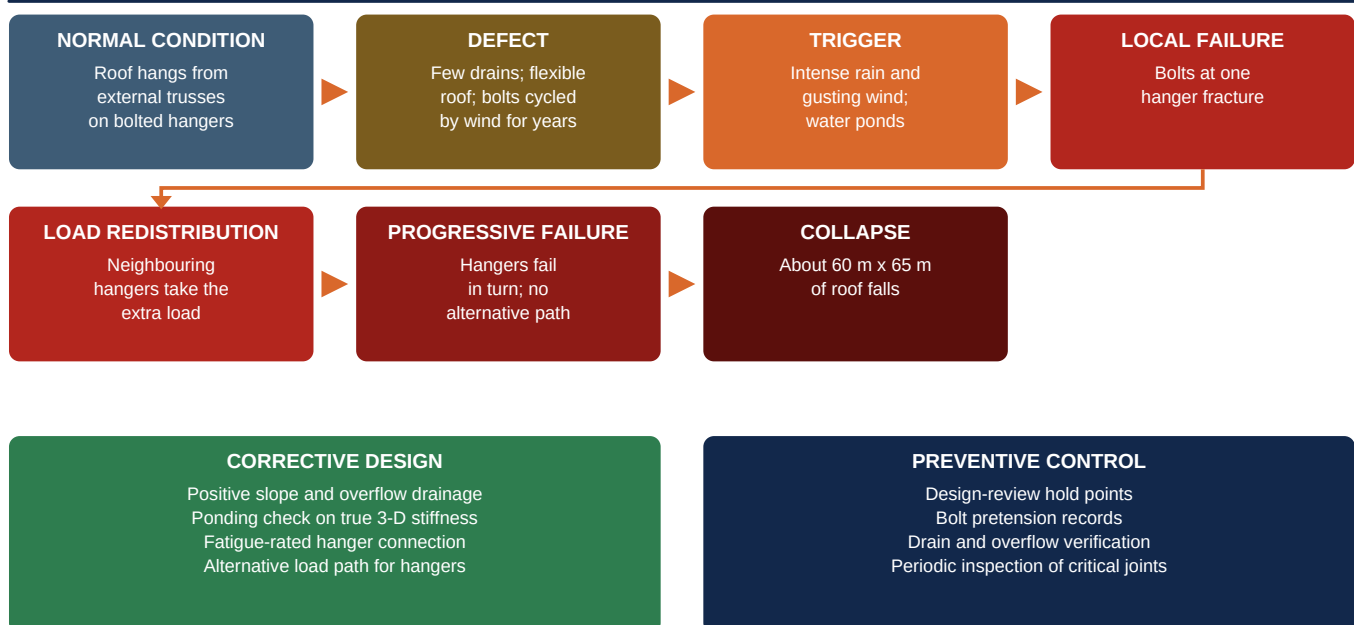
## 16 ORIGINAL IMBF FAILURE DIAGRAM

Original IMBF schematic. Conceptual, not to scale.
