# INDIAN METAL BUILDING FORUM

## STEEL STRUCTURE FAILURE & LESSONS LEARNED

### Steel Exhibition Hall Roof Collapse: Snow and Ice Load on an Under-Strength Series System

Katowice Fair Building, Chorzow / Katowice, Poland | 28 January 2006

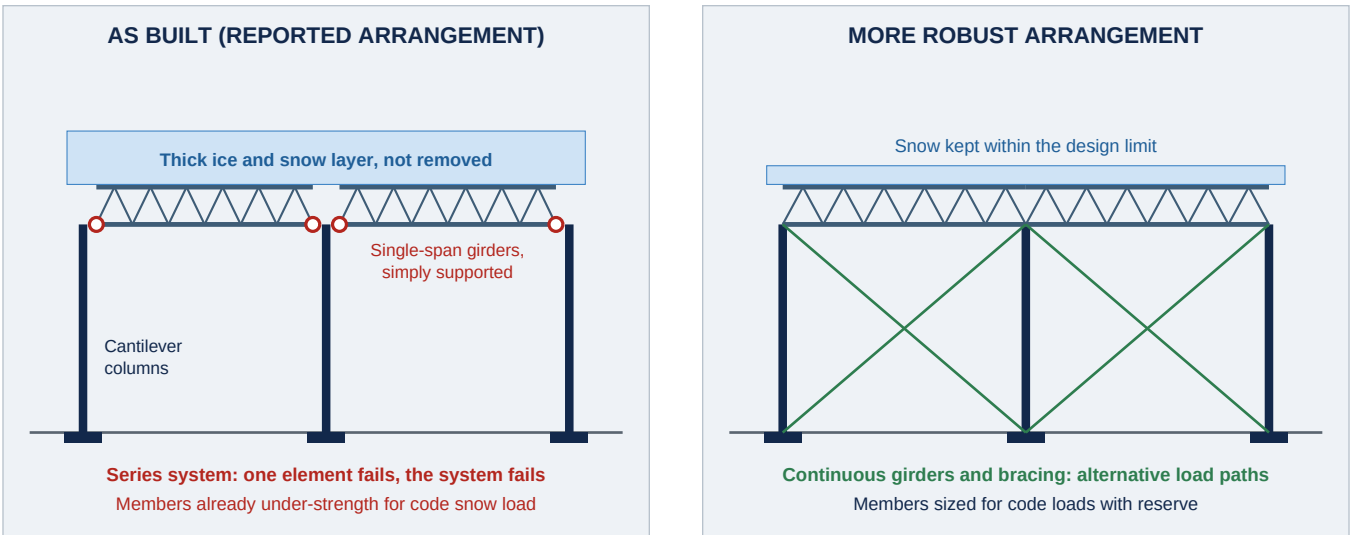
Figure 1. Original IMBF schematic of the reported structural system and a more robust alternative. Conceptual, not to scale; number of bays and members simplified.

**Series system.** Each single-span member rested on the next, and the columns were cantilevers. Such a system has the strength of its weakest element: when one reaches capacity, nothing else can take over. [S1]

- Design the primary structure with continuity and bracing so that the loss of one element does not bring down the roof.
- Size members for code loads, including drift and accumulation at lanterns, parapets and level changes.
- After any partial failure, reassess the whole design independently before repair and reuse.
- Give the owner a snow and roof-load management plan with a measurable limit and an instruction to clear or close.
